**CONSENT ORDER
ISSUED UNDER THE
WATER POLLUTION CONTROL ACT
WEST VIRGINIA CODE, CHAPTER 22, ARTICLE 11**

TO: MarkWest Liberty Midstream & Resources, L.L.C. DATE: March 28, 2019
Gregory Bezdek, SVP, NE Region
4600 J Barry Ct. Ste 500
Canonsburg, PA 15317 ORDER NO.: 8945

MARKWEST LIBERTY MIDSTREAM & RESOURCES, L.L.C, WVR311004, Sherwood to Mobley
20" NGL, 8/22 & 8/23/2018

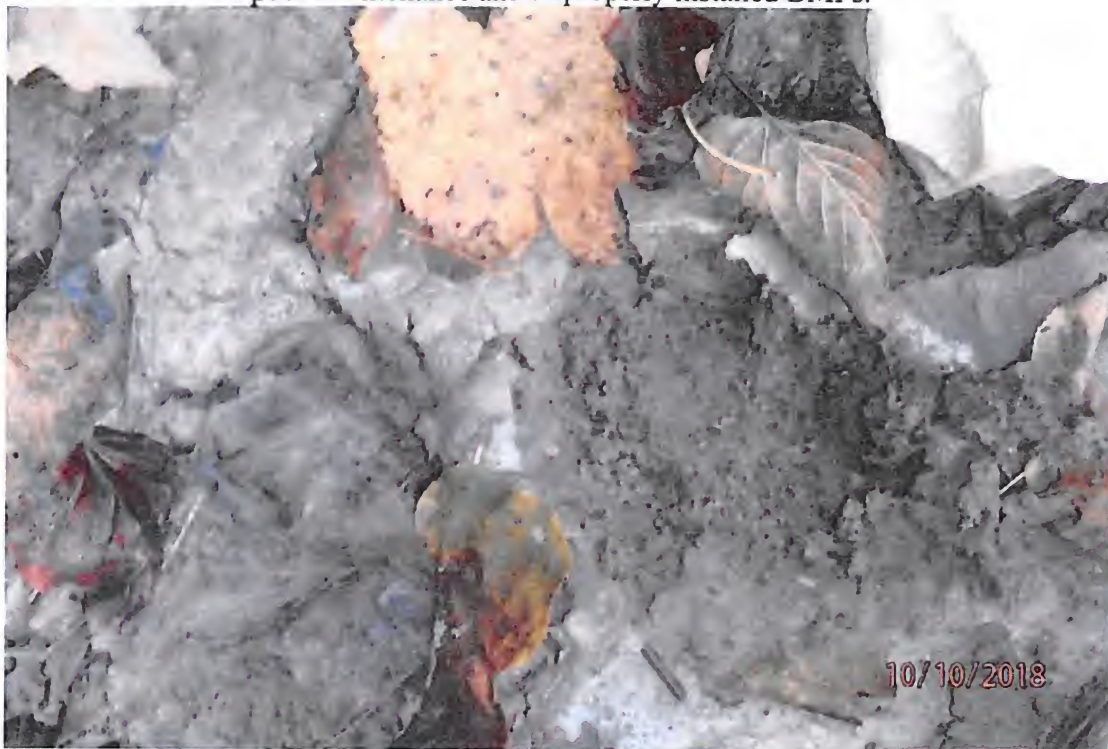
Overview of installed BMPs adjacent to UNT Buckeye Creek (UNT59) showing offsite sediment due to poor maintenance and improperly installed BMPs.

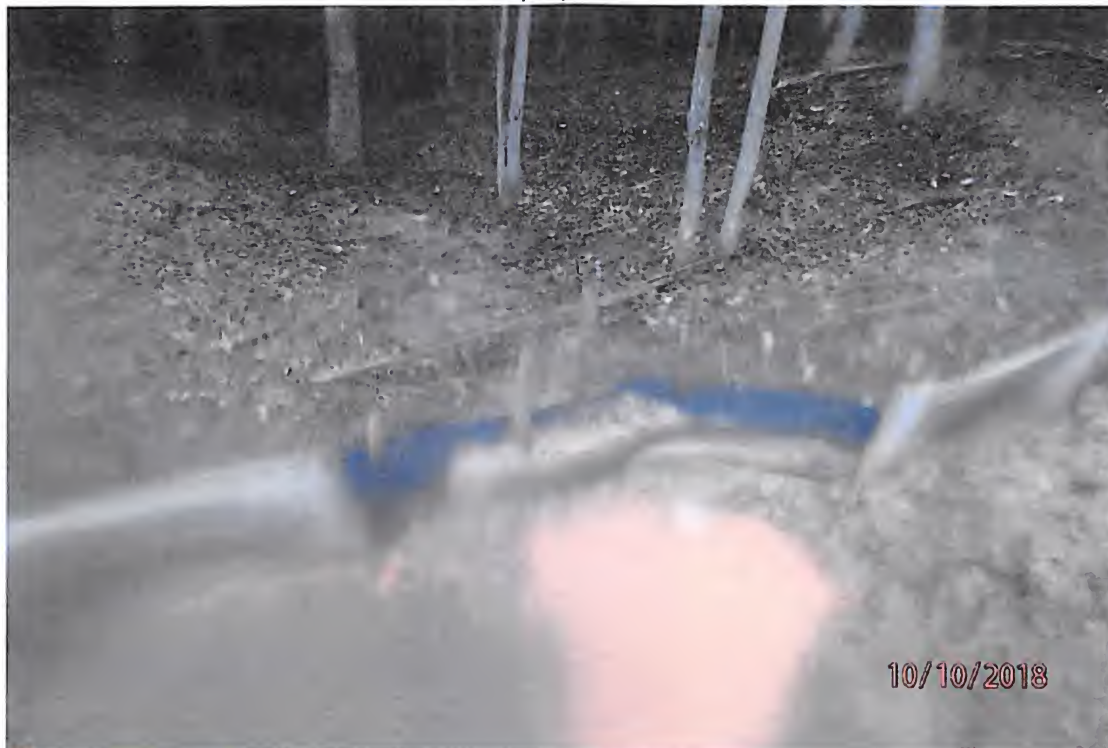
Offsite CNA deposits in UNT Righthand Fork of Morgans Run (UNT 2) (39°17.932' X 80°40.600').

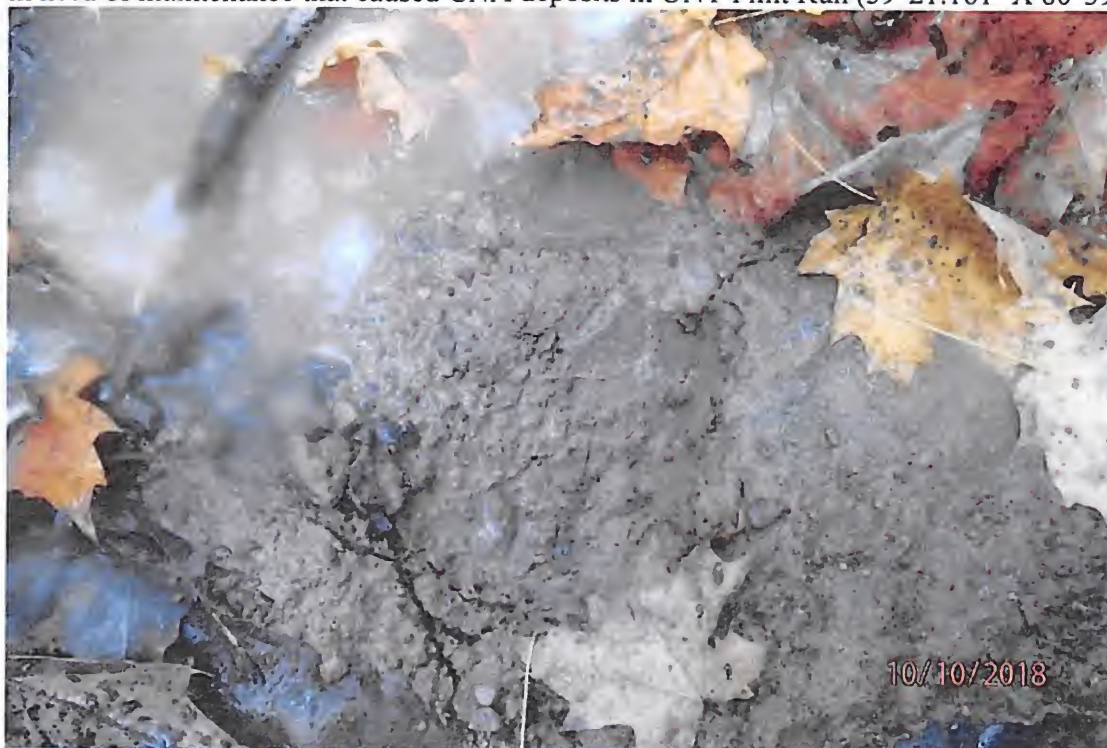
BMP in need of maintenance that caused CNA deposits in UNT Flint Run (39°21.161' X 80°39.549')

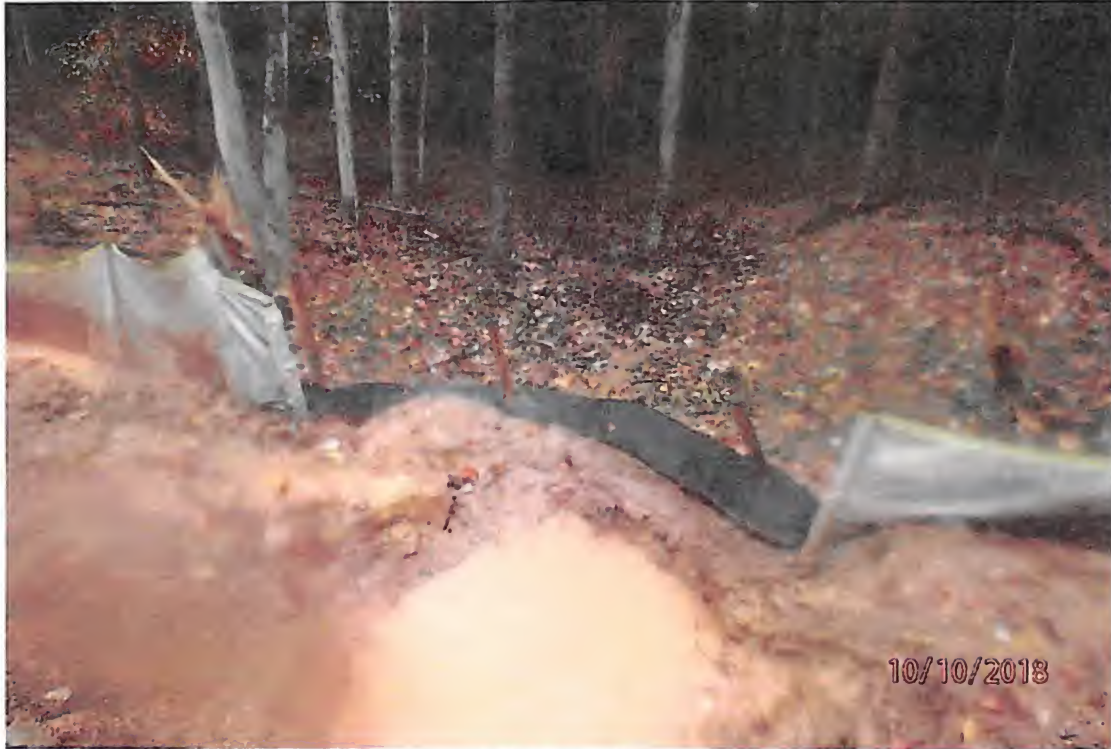
Offsite CNA deposits in UNT Flint Run (39°21.161' X 80°39.549').

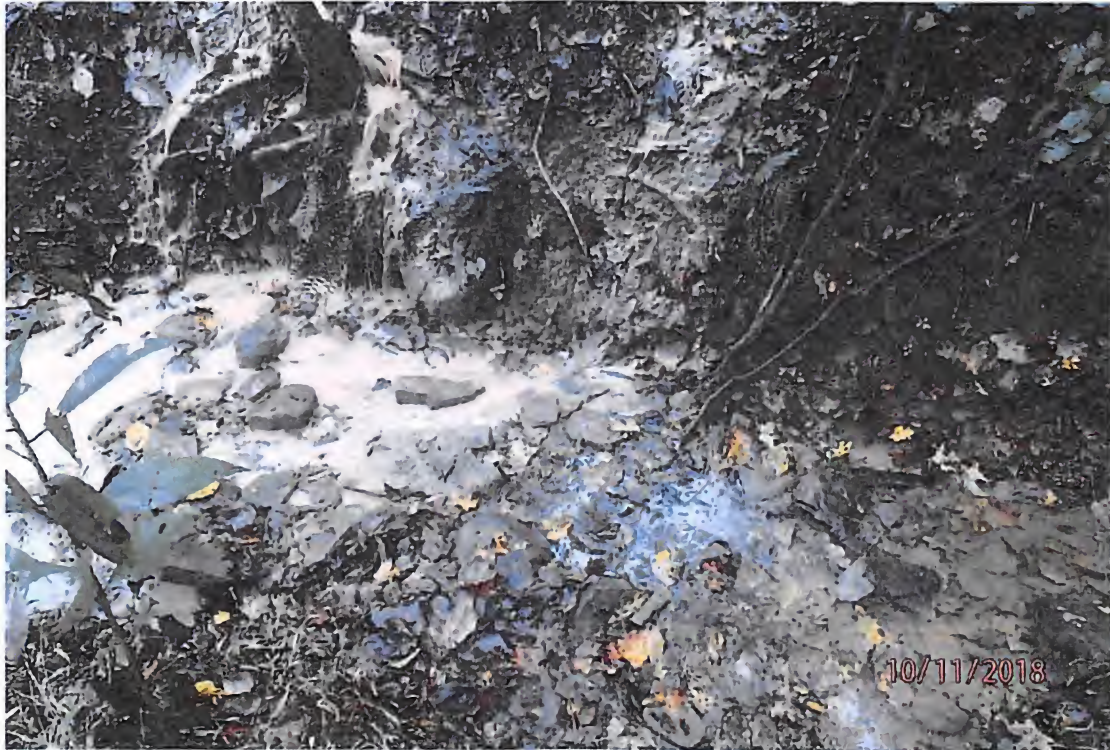
Sediment laden water bypassing an unmaintained and poorly operated water bar terminus BMP adjacent to UNT Franks Run (39°25.922' X 80°37.079').

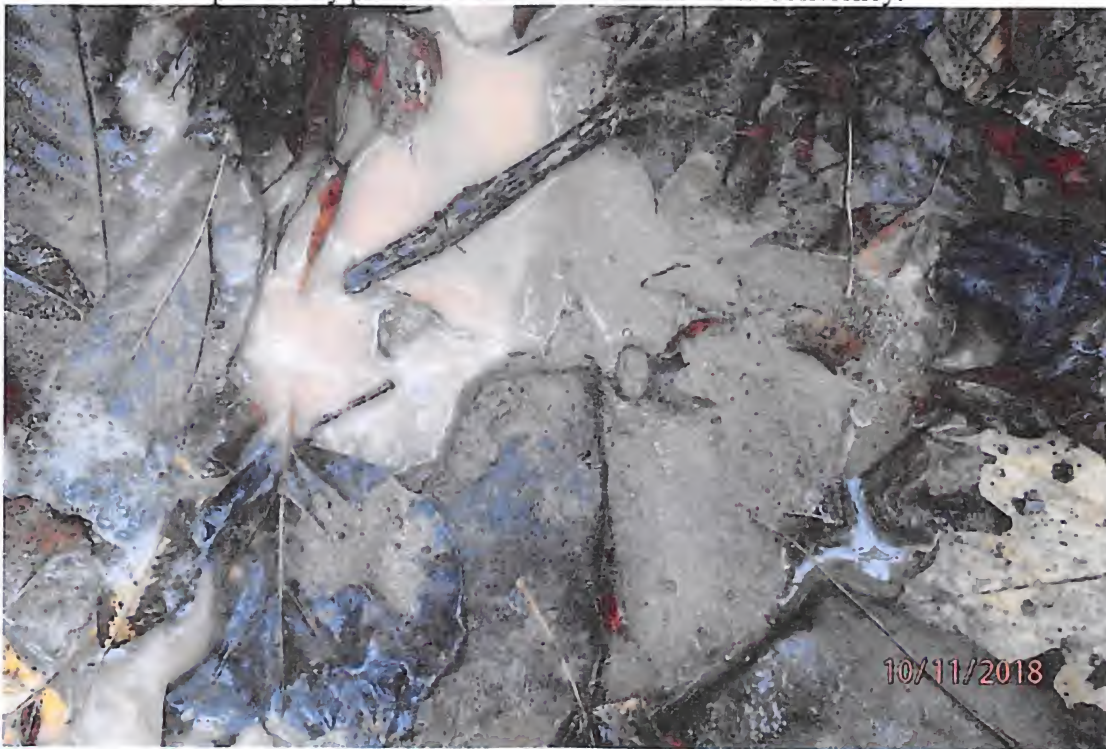
CNA distinctly visible settleable solids in UNT Franks Run (39°25.922' X 80°37.079') as a result of the previously pictured water bar terminus BMP deficiency.

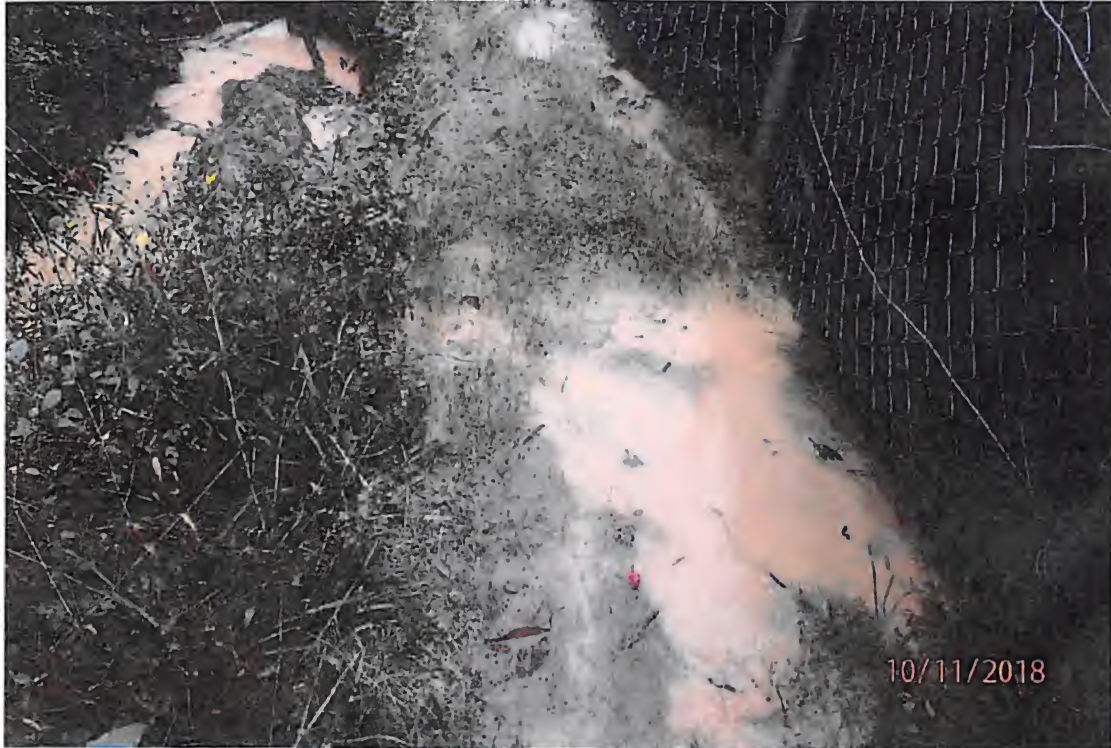
CNA deposits in UNT Franks Run (39°25.922' X 80°37.079') as a result of the previously pictured water bar terminus BMP deficiency.

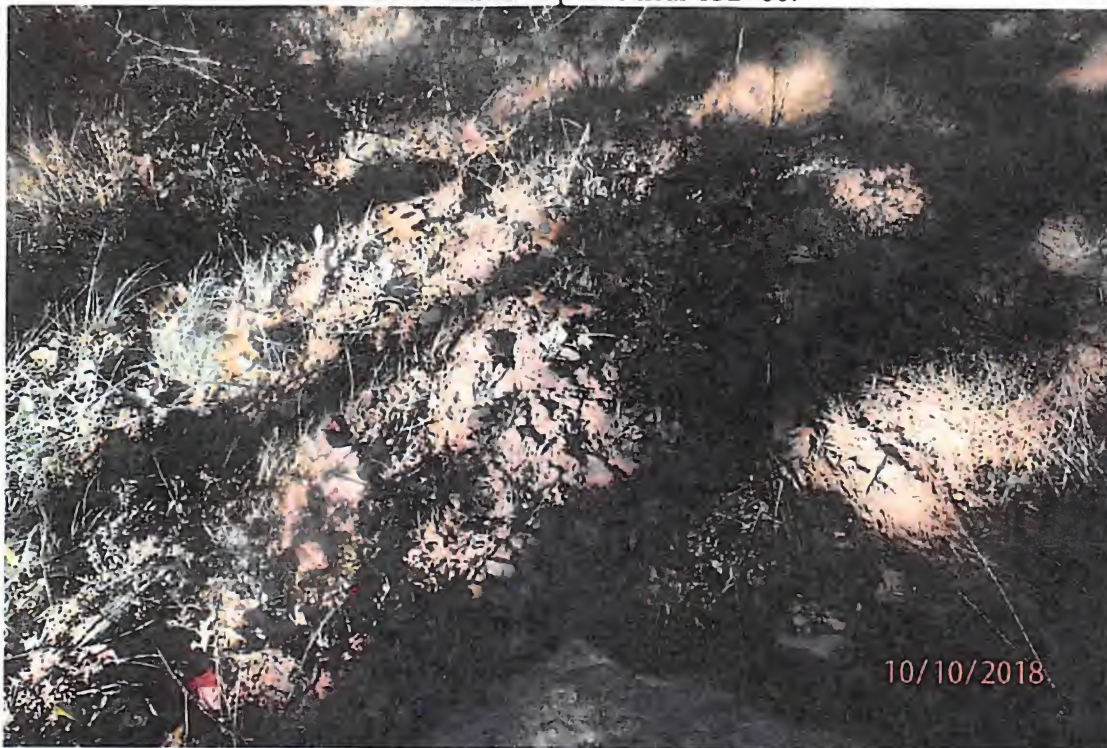
Diversion berm outlet BMP that has been overwhelmed and is in need of maintenance with associated offsite sediment deposits near 132+00.

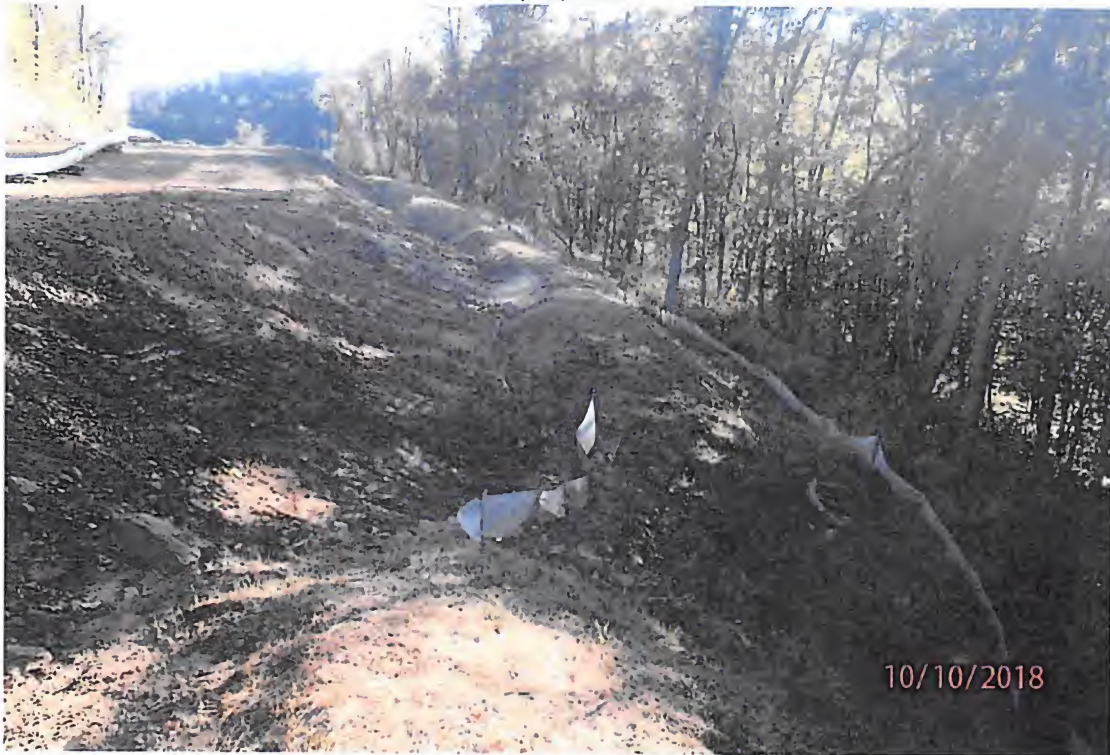
Offsite deposits as a result of above pictured deficiency near 132+00.

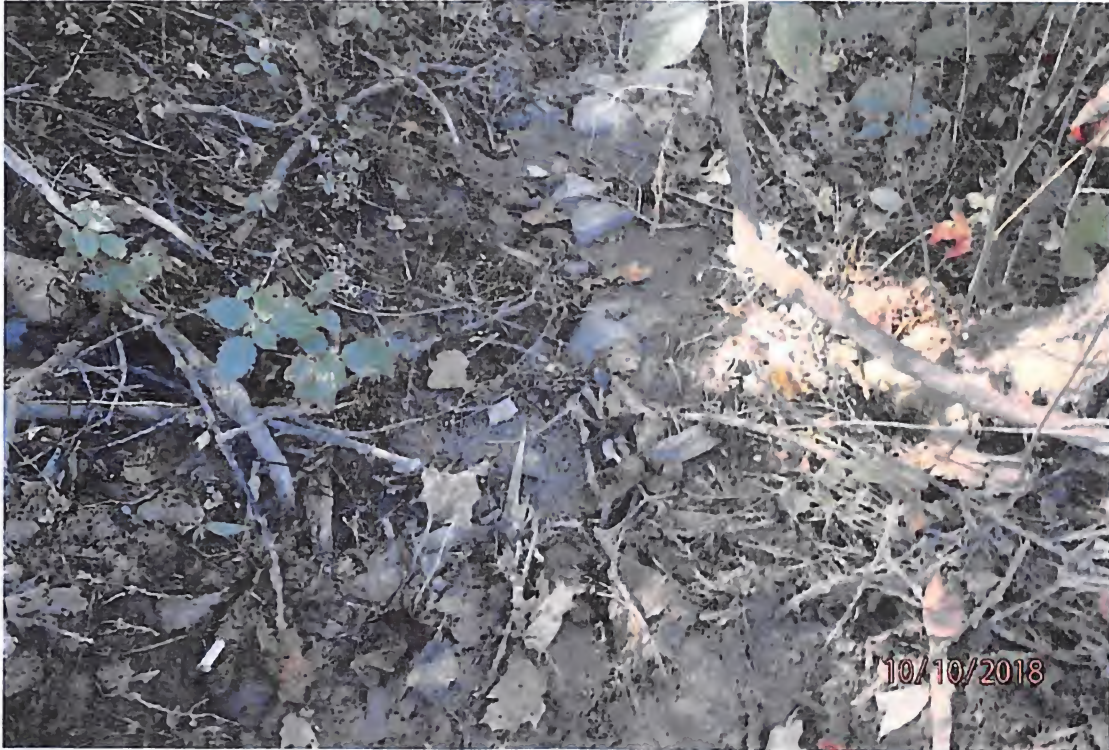
Diversion berm outlet BMP that has been overwhelmed and is associated with offsite CNA deposits near UNT Morgans Run (39°17.506' X 80°40.813').

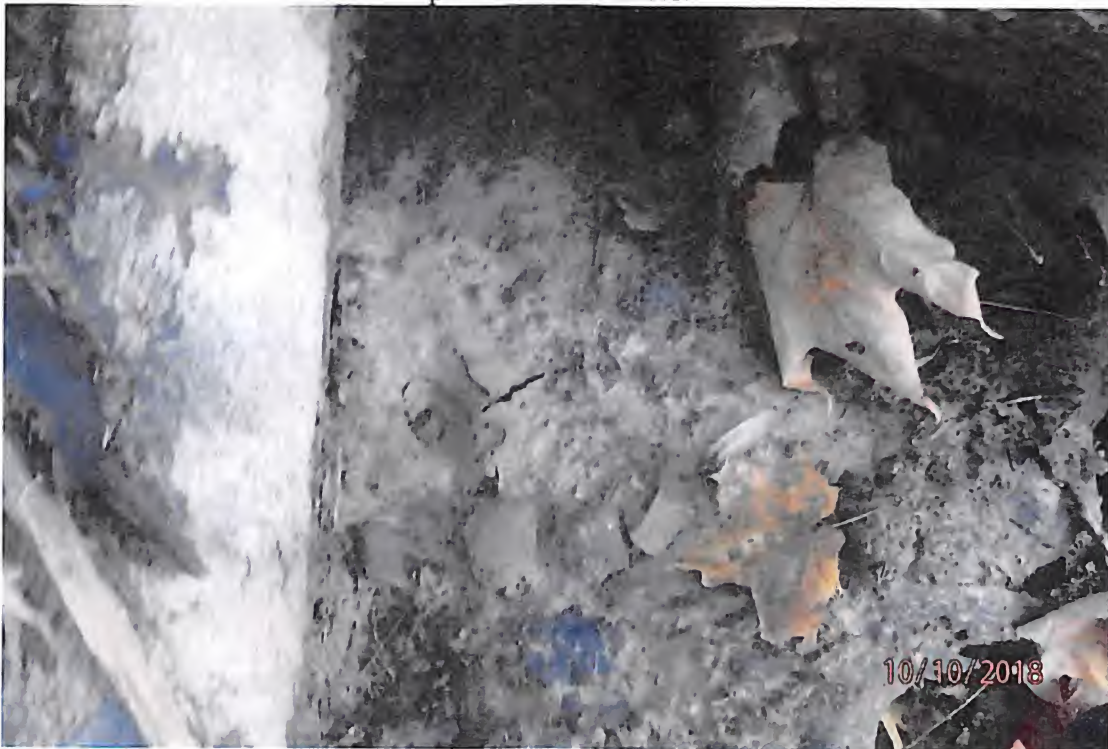
Offsite CNA deposits in UNT Morgans Run (39°17.506' X 80°40.813') as a result of the previously pictured deficiencies.

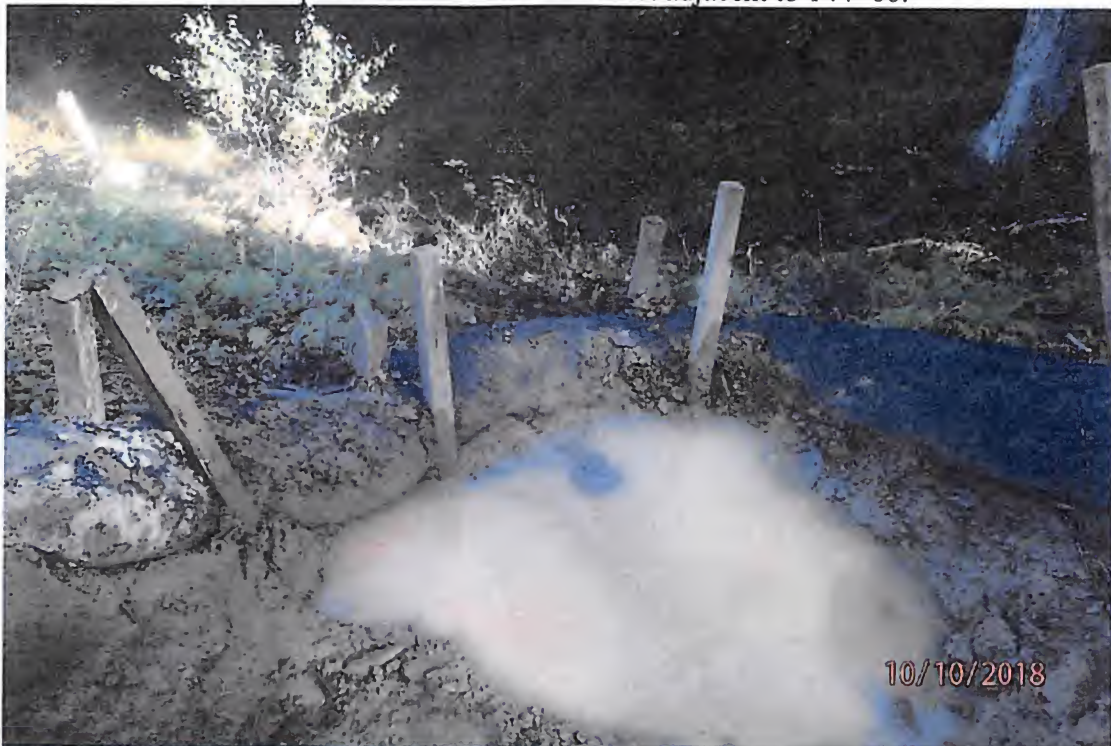
Fill slope erosion at water bar outlet adjacent to 144+00.

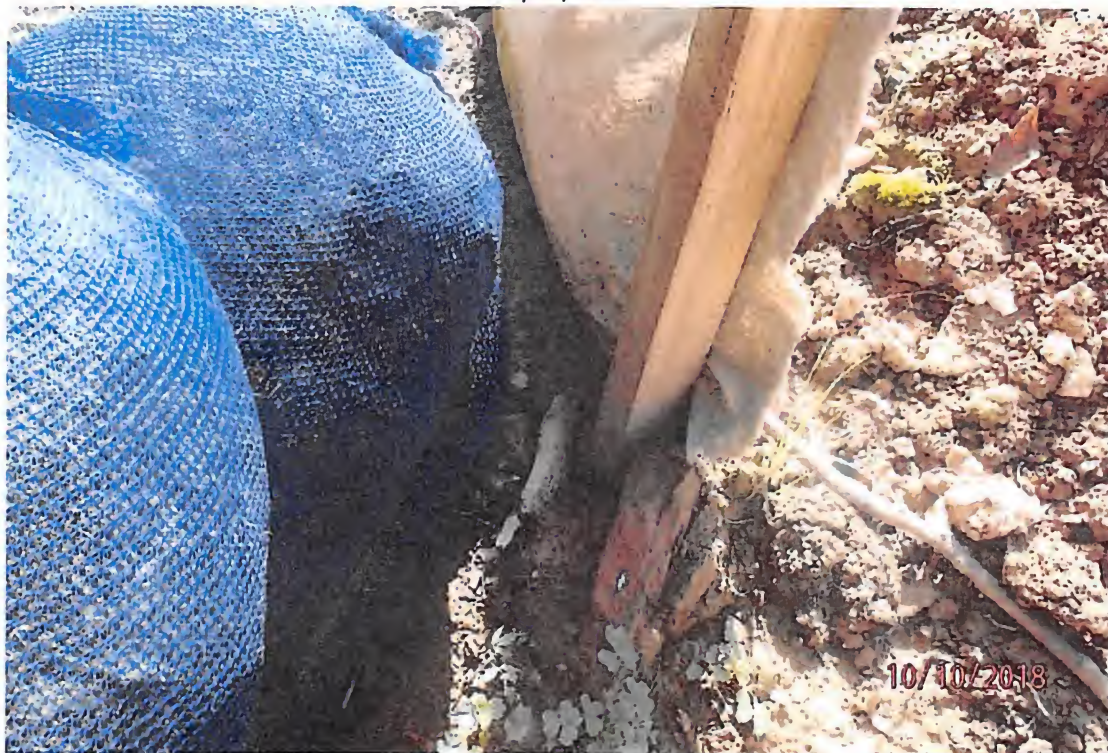
Improperly installed water bar terminus BMP in Wolfepen Run watershed.

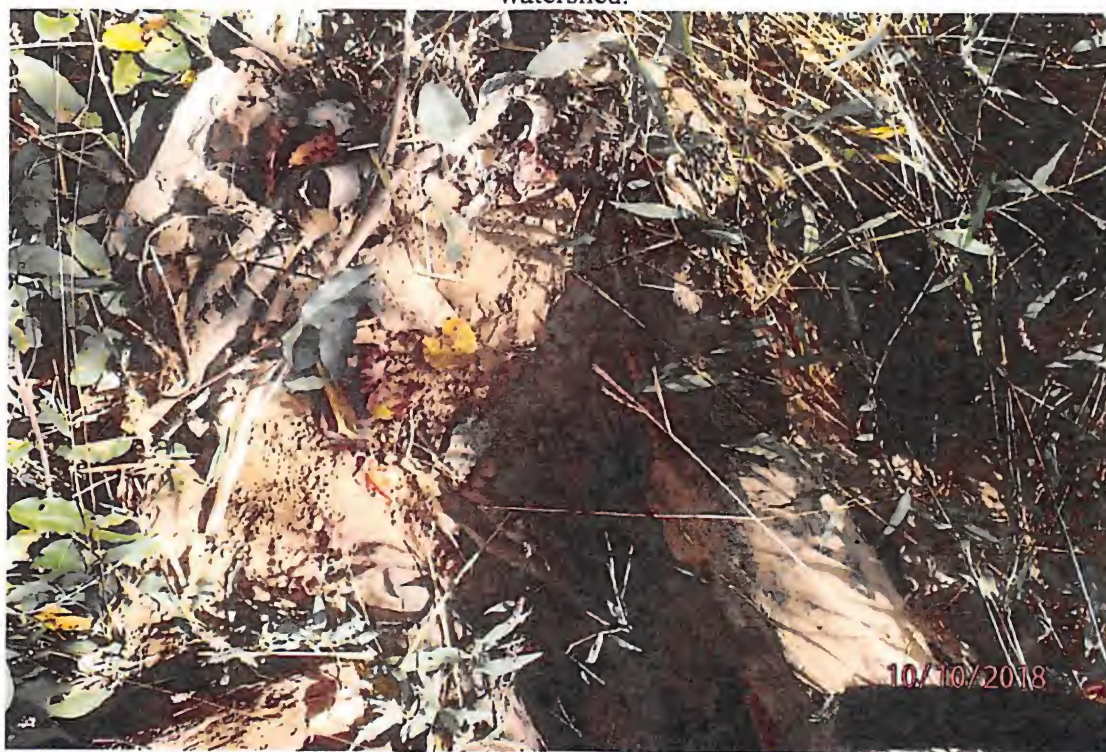
Improperly installed water bar terminus BMP which allowed offsite sediment deposits in Wolfpen Run watershed.

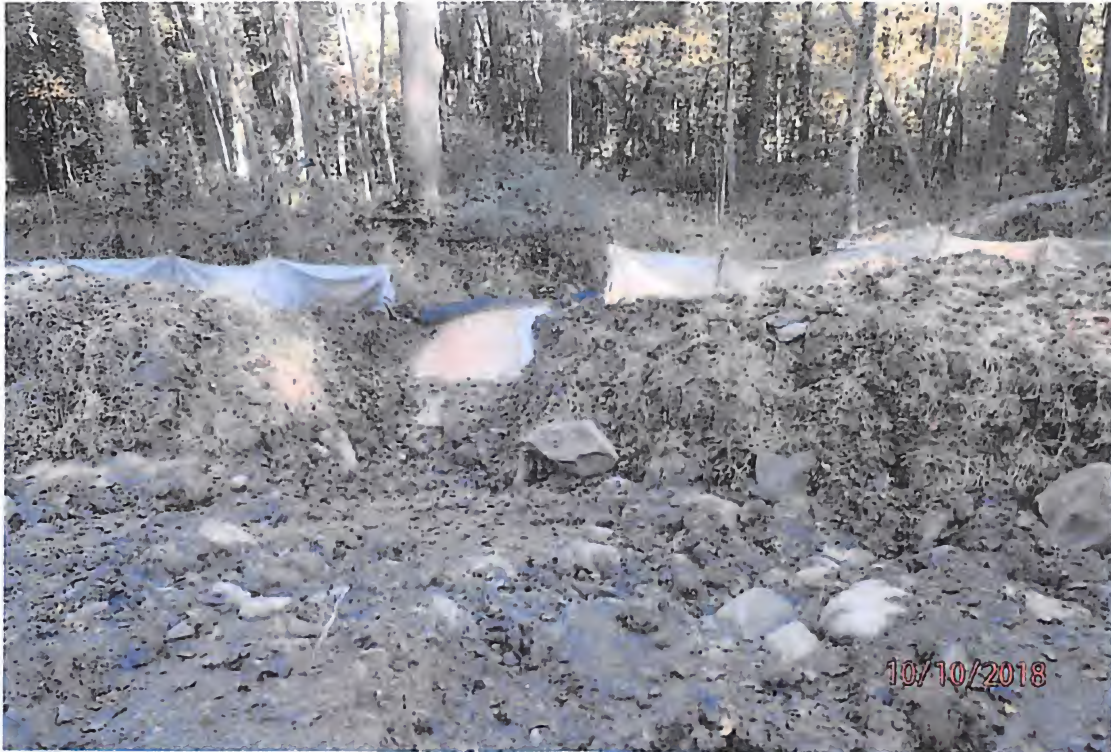
Offsite sediment deposits in Wolfpen Run watershed due to above pictured deficiency.

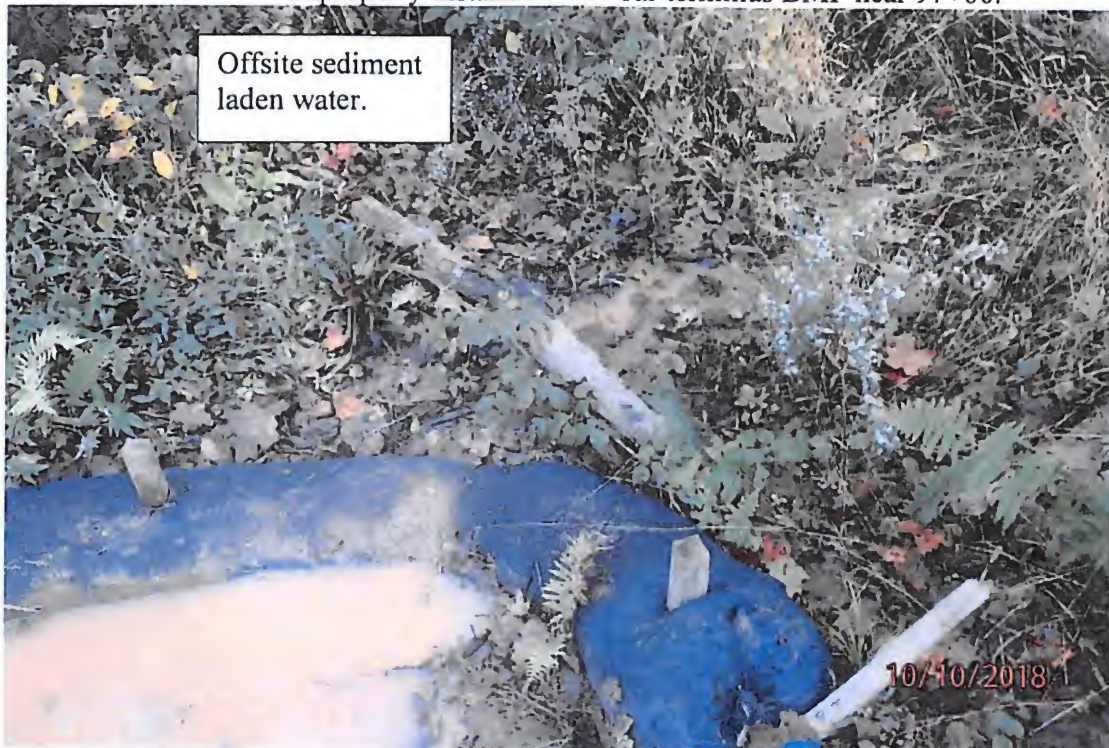
Overview of improperly installed water bar terminus BMP near 97+00.

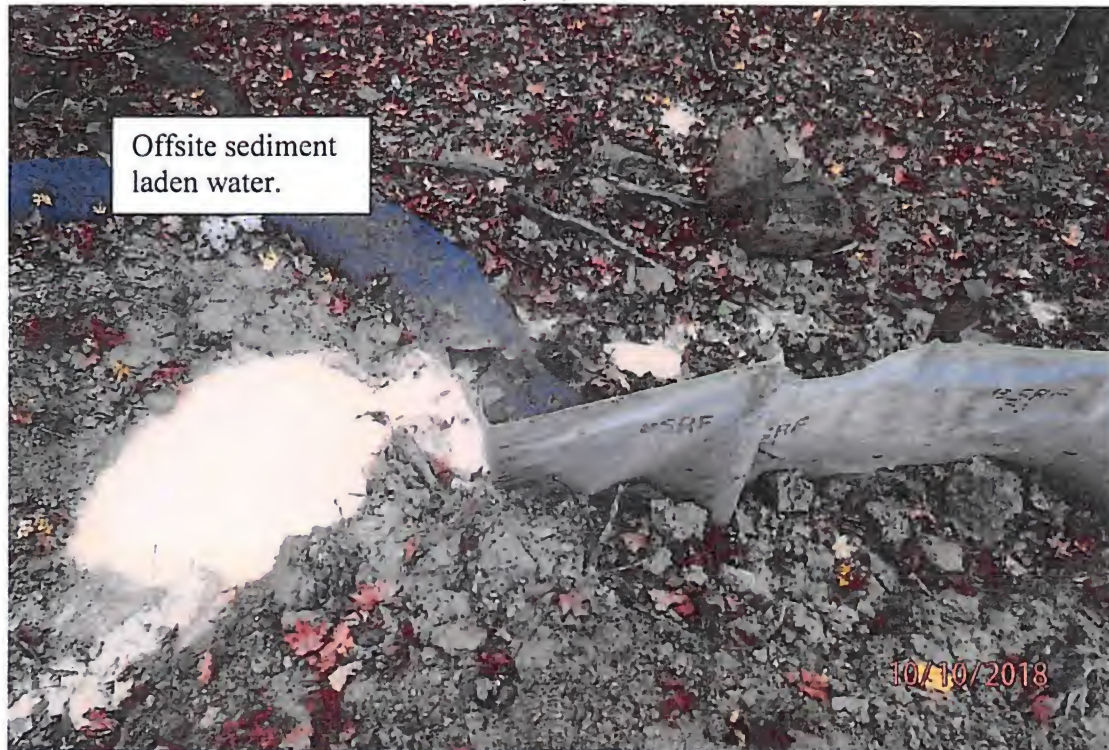
Improperly installed water bar terminus BMP which allows sediment laden water to bypass under the BMP near 97+00.

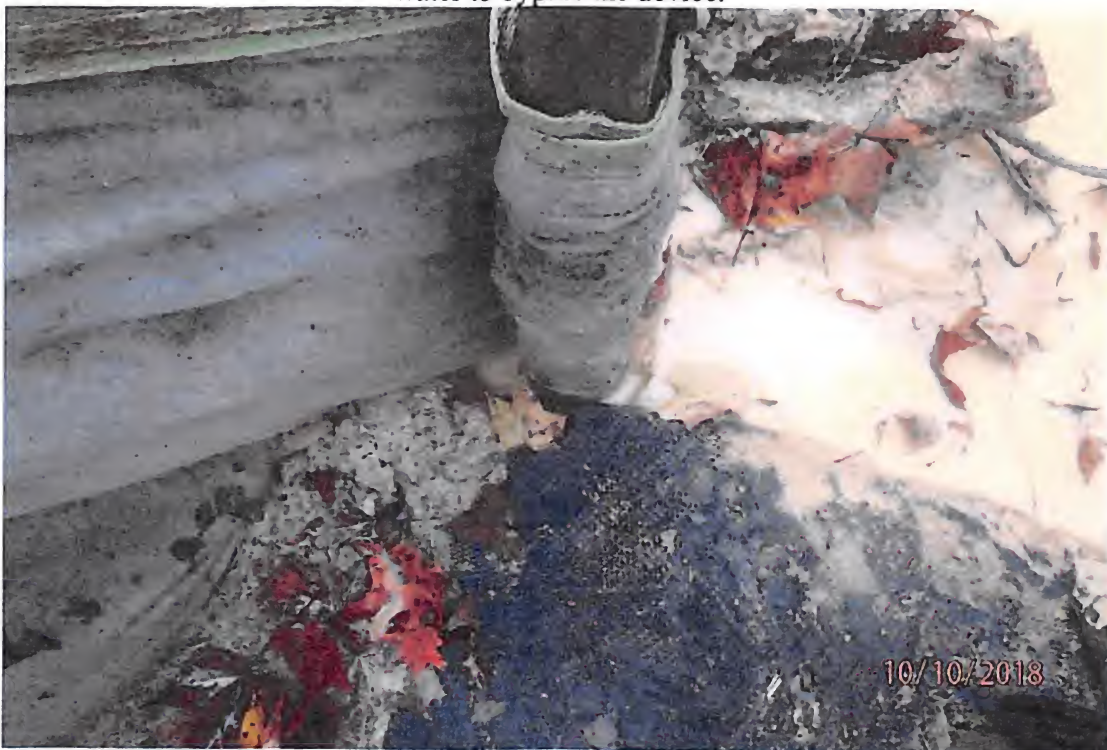
Improperly installed water bar terminus BMP in the Riggins Run watershed that allows sediment laden water to bypass the device.

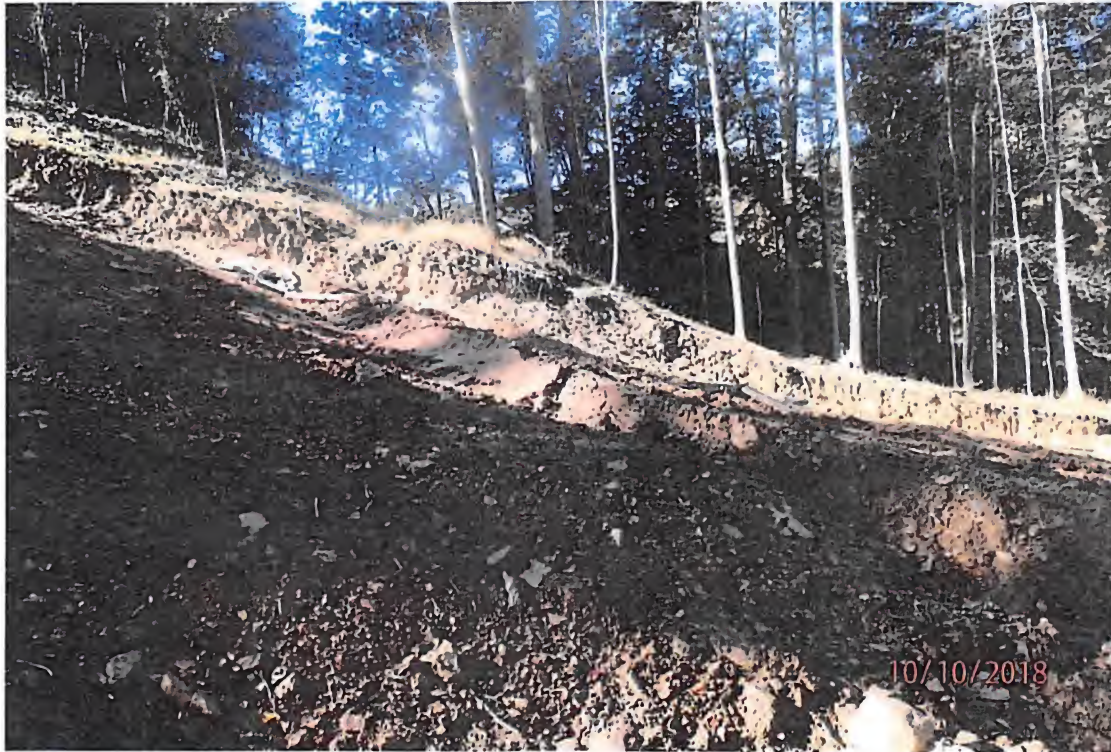
Improperly installed water bar terminus BMP in the Riggins Run watershed that allows sediment laden water to bypass the device.

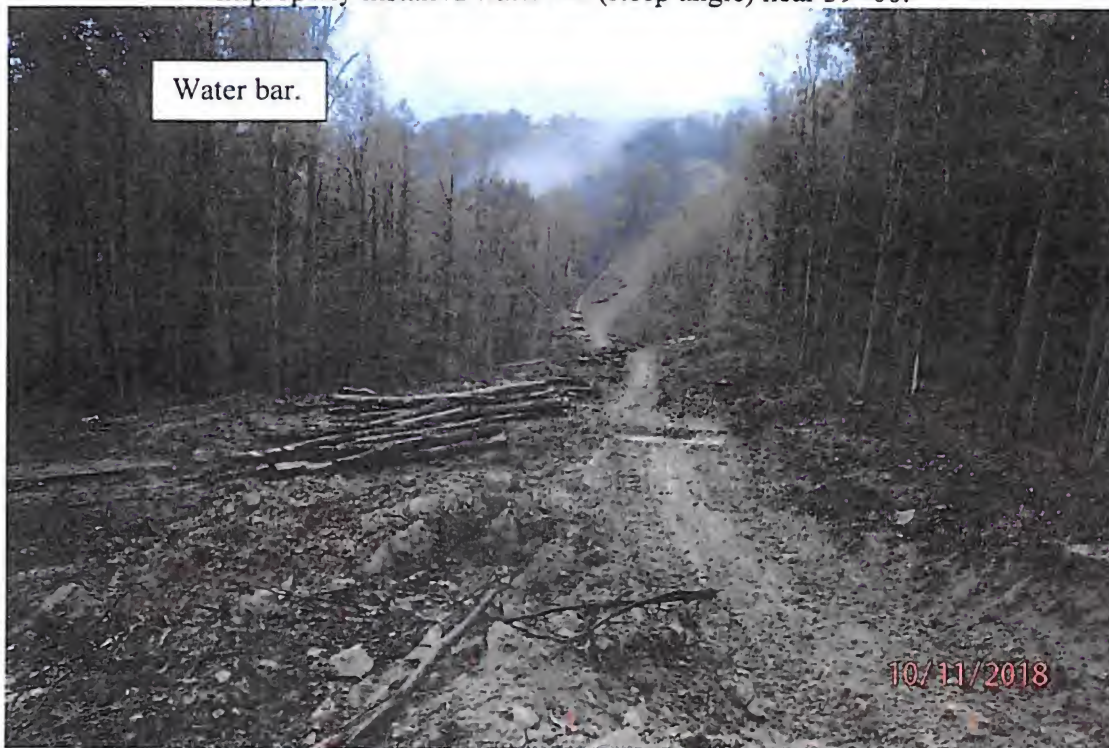
Improperly installed water bar (steep angle) near 39+00.

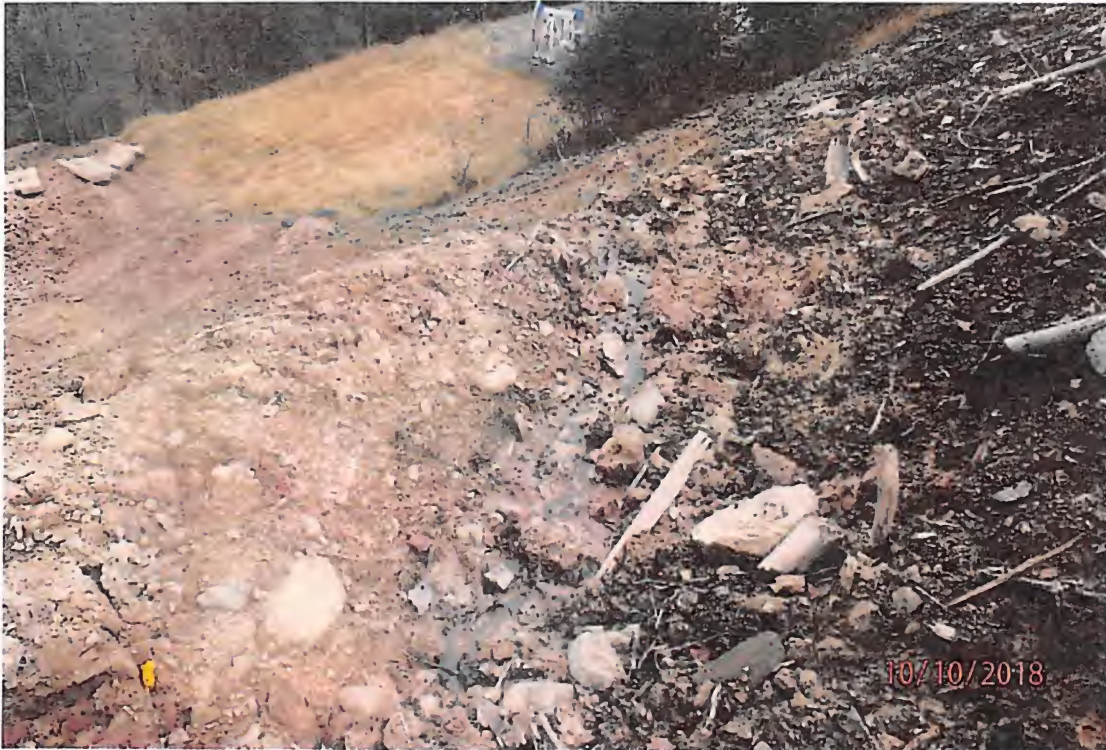
Improperly installed water (does not discharge off site as designed) near 551+00.

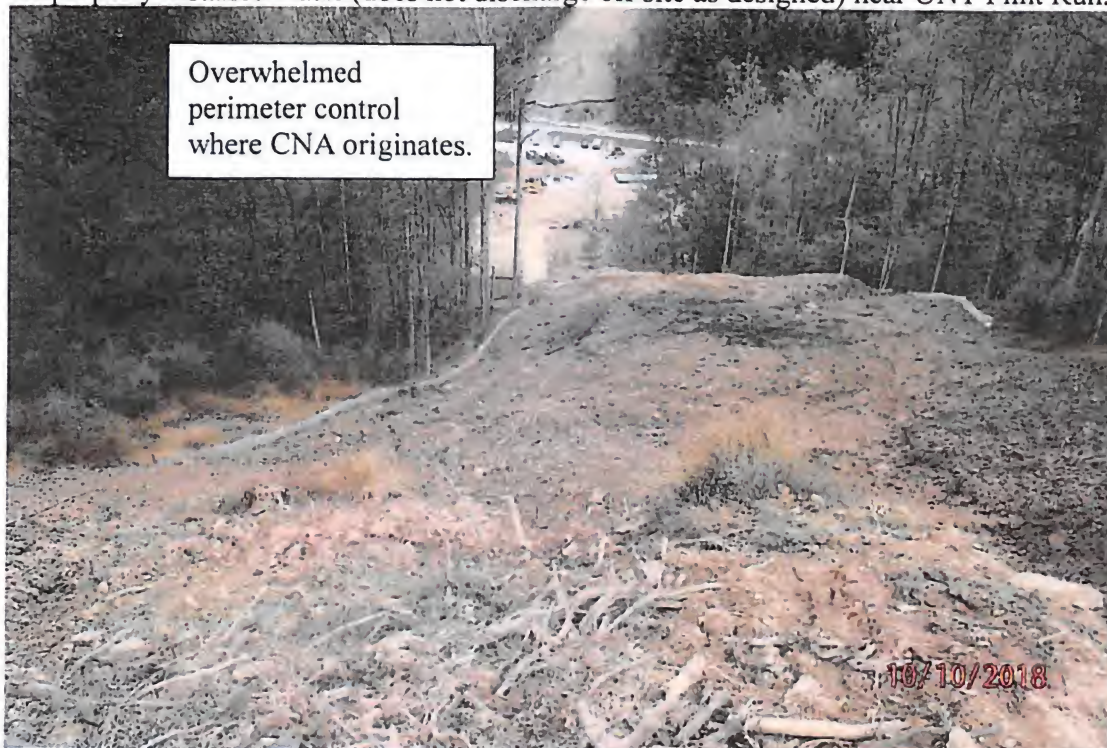
Improperly installed water (does not discharge off site as designed) near UNT Flint Run.

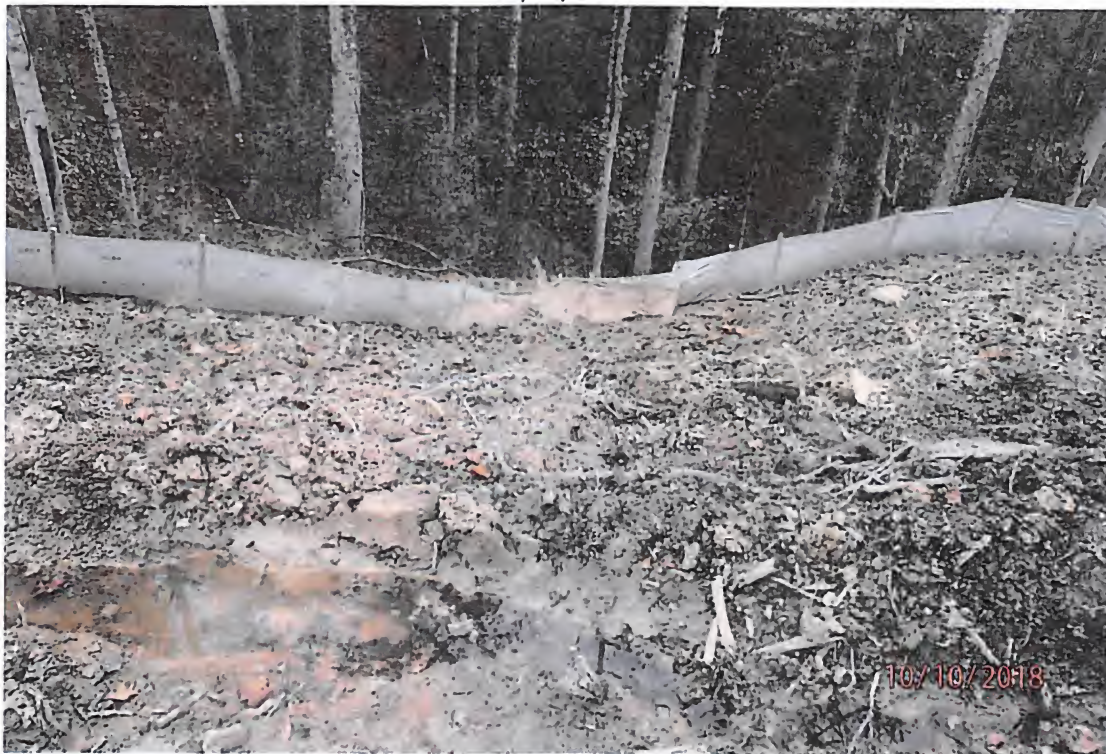
Area lacking properly installed water bars adjacent to UNT Flint Run. This caused excessive stormwater to overwhelm the installed BMP and caused CNA deposits in UNT Flint Run (39°20.058' X 80°39.931').

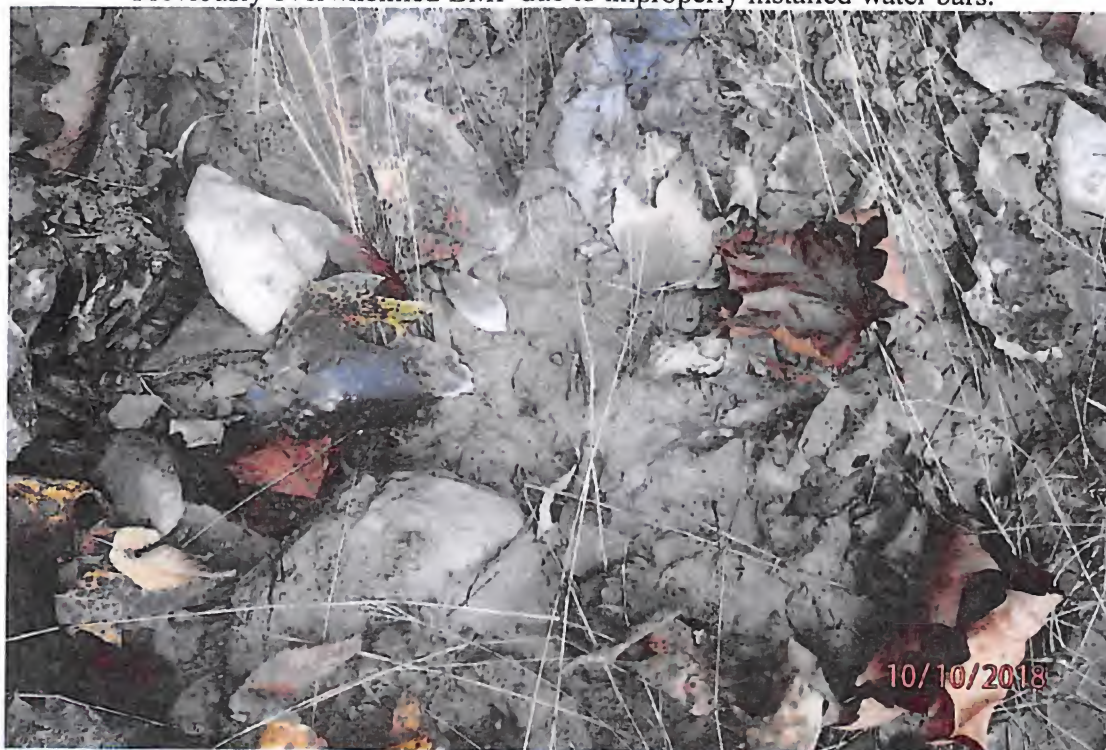
Previously overwhelmed BMP due to improperly installed water bars.

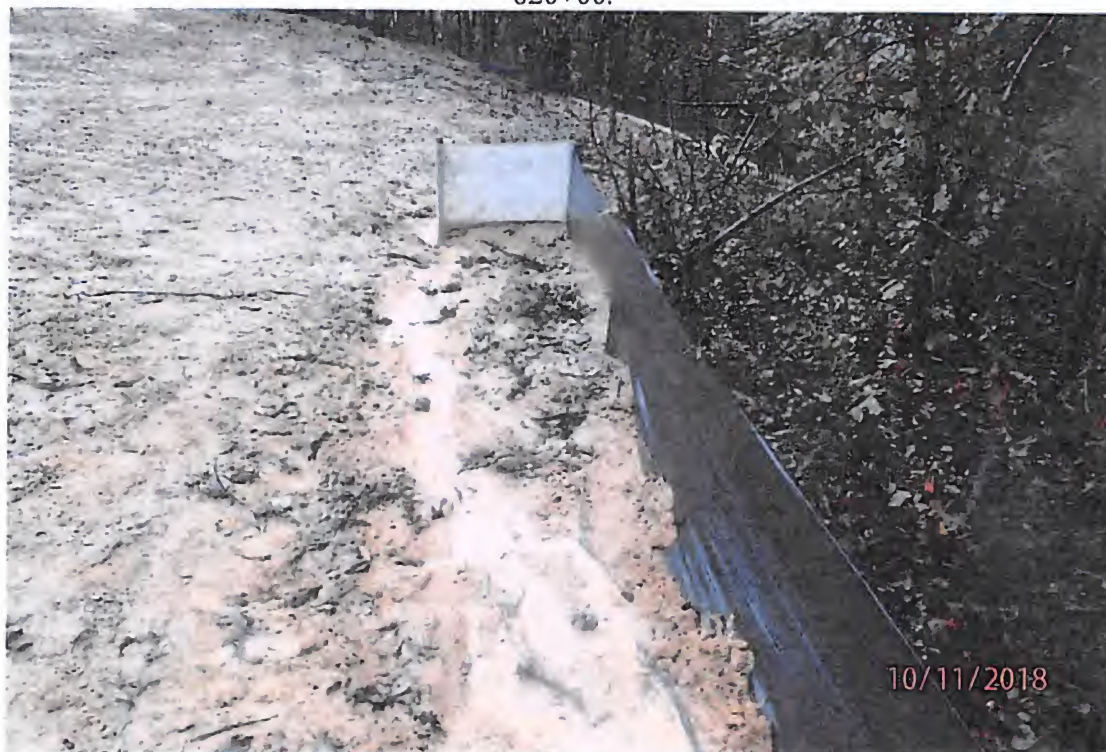
Improperly installed water bar that does not shed stormwater offsite in small quantities as designed near 820+00.

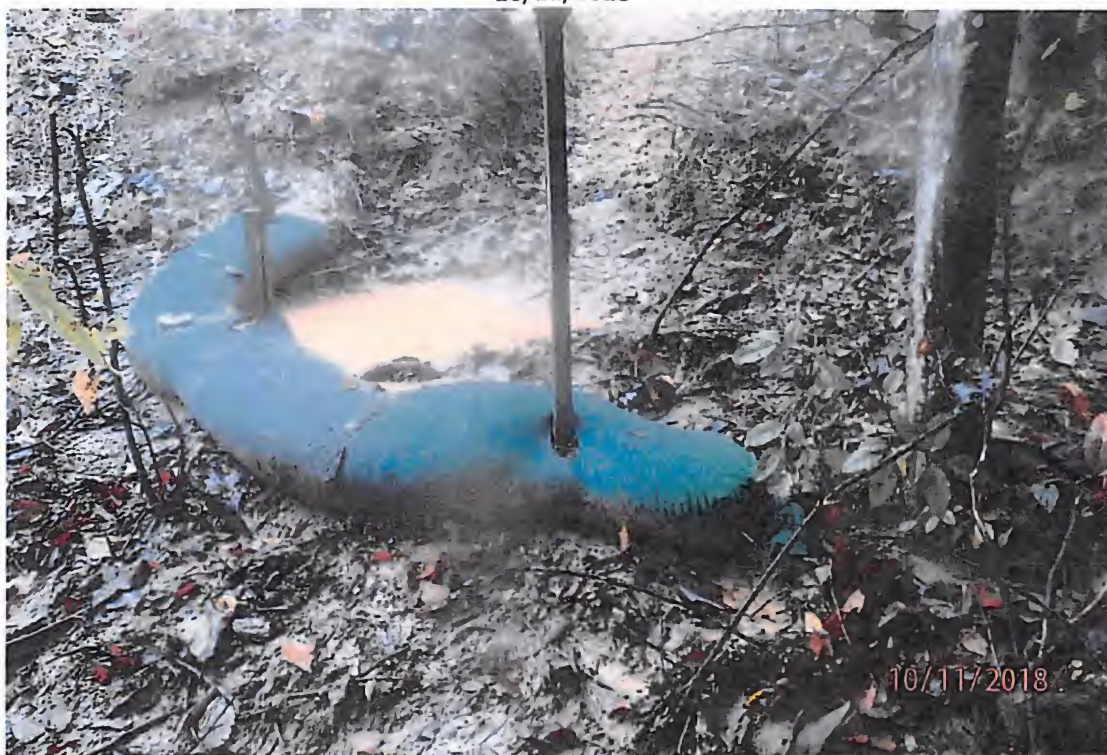
Sediment laden water bypassing perimeter controls adjacent to 820+00.

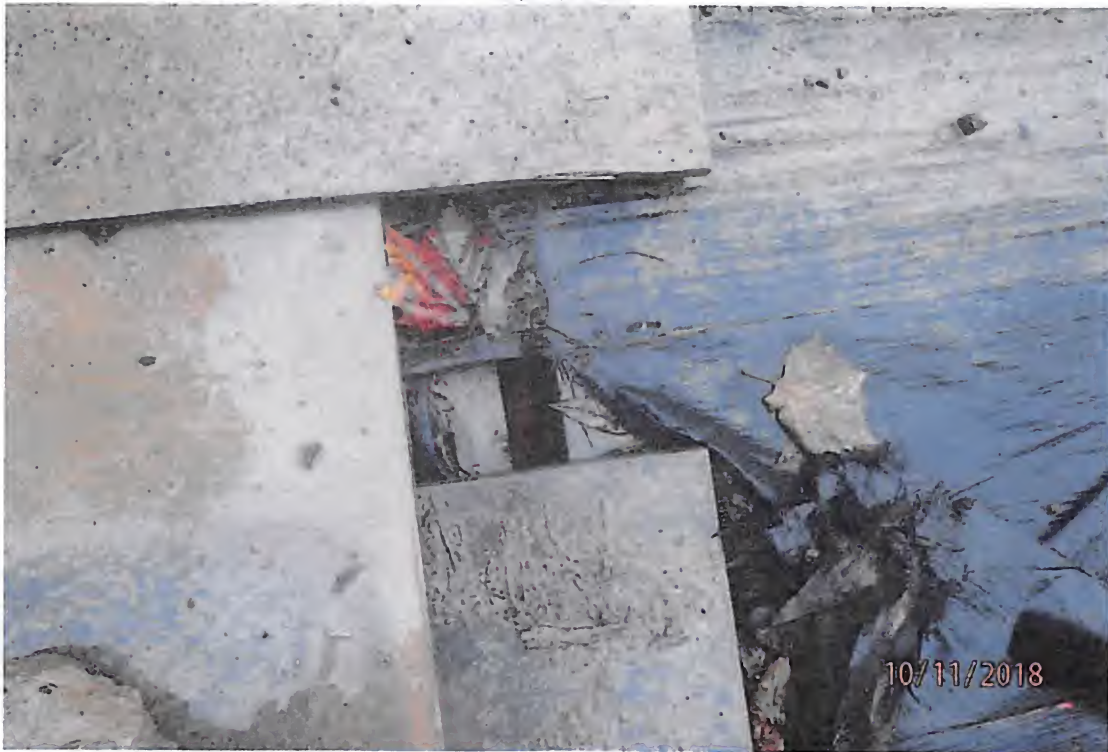
Evidence of sediment laden water bypass under the above pictured bridge (Crossing # 48).
